LIGHTNING TRANSIENT RESEARCH ON AN F-111E AIRCRAFT

TECHNICAL REPORT AFFDL-TR-78-1
Final Report for Period June 1976 - December 1976

AIR FORCE FLIGHT DYNAMICS LABORATORY
AIR FORCE WRIGHT AERONAUTICAL LABORATORIES
AIR FORCE SYSTEMS COMMAND
WRIGHT-PATTERSON AIR FORCE BASE, OHIO 45433

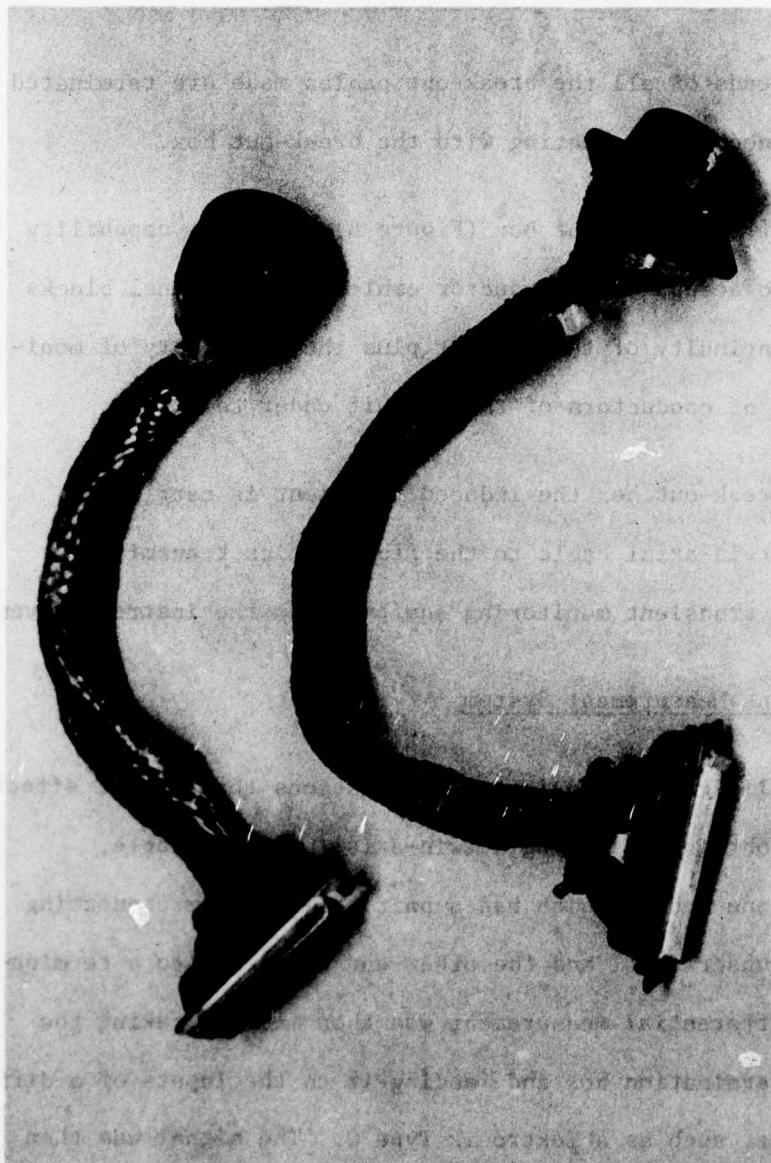
FIGURE 7
MULTICONDUCTOR CABLES USED
WITH BREAK-OUT BOX

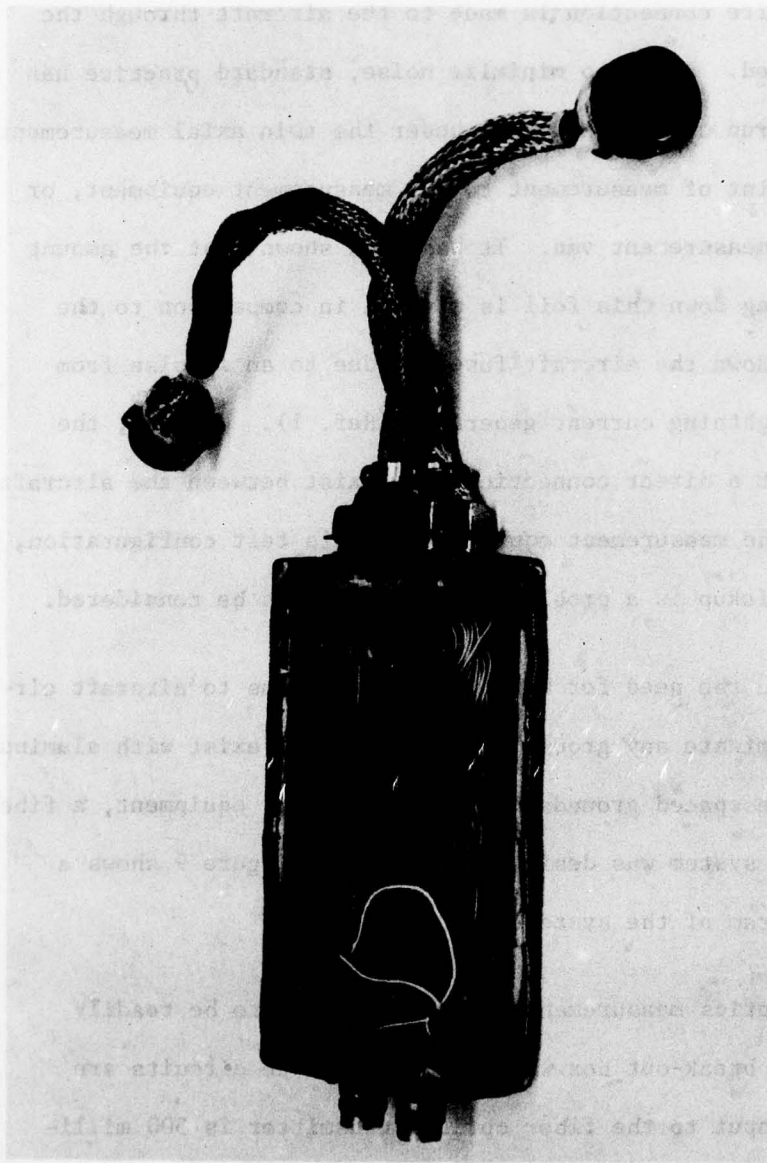
FIGURE 8
INTERIOR OF BREAK-OUT BOX
SHOWING TERMINAL BLOCKS

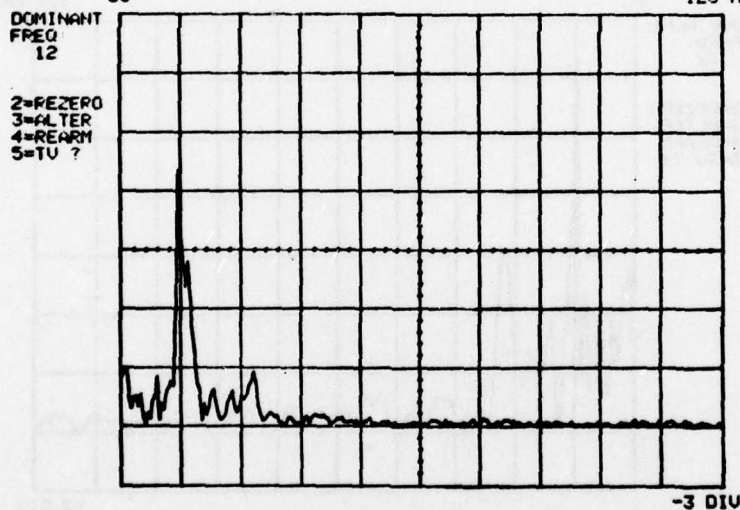
Figure 24. Induced Voltage and Frequency Spectrum
Roll Damper Servo, J17042, pins 1-3, Branch B
